## Bumper/Fascia Replacement with Advanced Driver Assistance Systems (ADAS)

June 2018

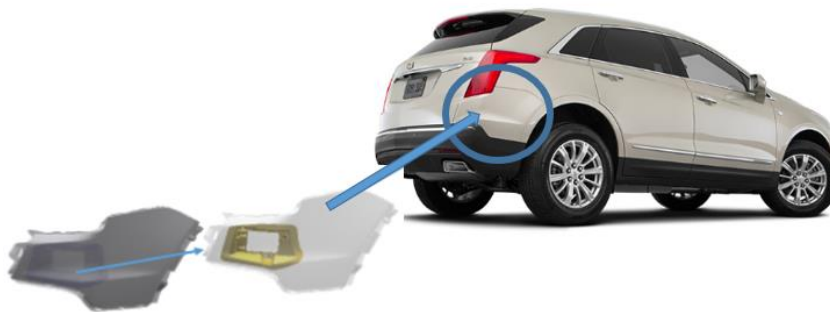
Figure 1.1

Depending on vehicle build configuration, the Bumper/Fascia system may have ADAS sensors attached to the inner surface that are not visible from the exterior of the vehicle (Please refer to Figure 1.1). GM is limiting repairs to these Bumper/Fascia systems on vehicles equipped with ADAS.

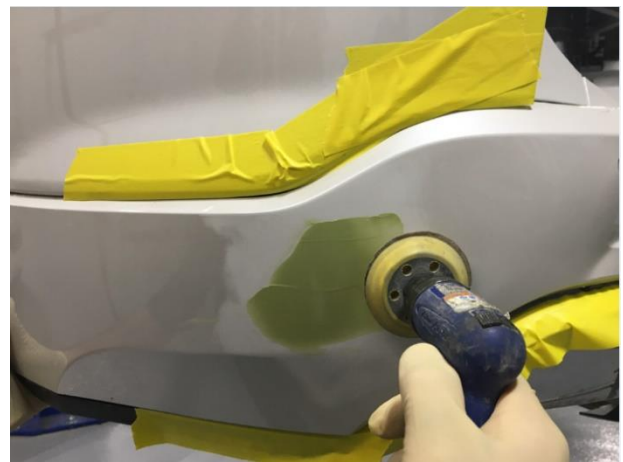
Any Bumper/Fascia equipped with ADAS(s) that requires substrate repair must be replaced. An example of substrate repair is shown in Figure 1.2
